**CLEAN WATER ACT COMPLIANCE INSPECTION
U.S. ENVIRONMENTAL PROTECTION AGENCY, REGION 5**

Legend Farms Dairy, LLC

Date of Inspection: April 20, 2017 - April 21, 2017

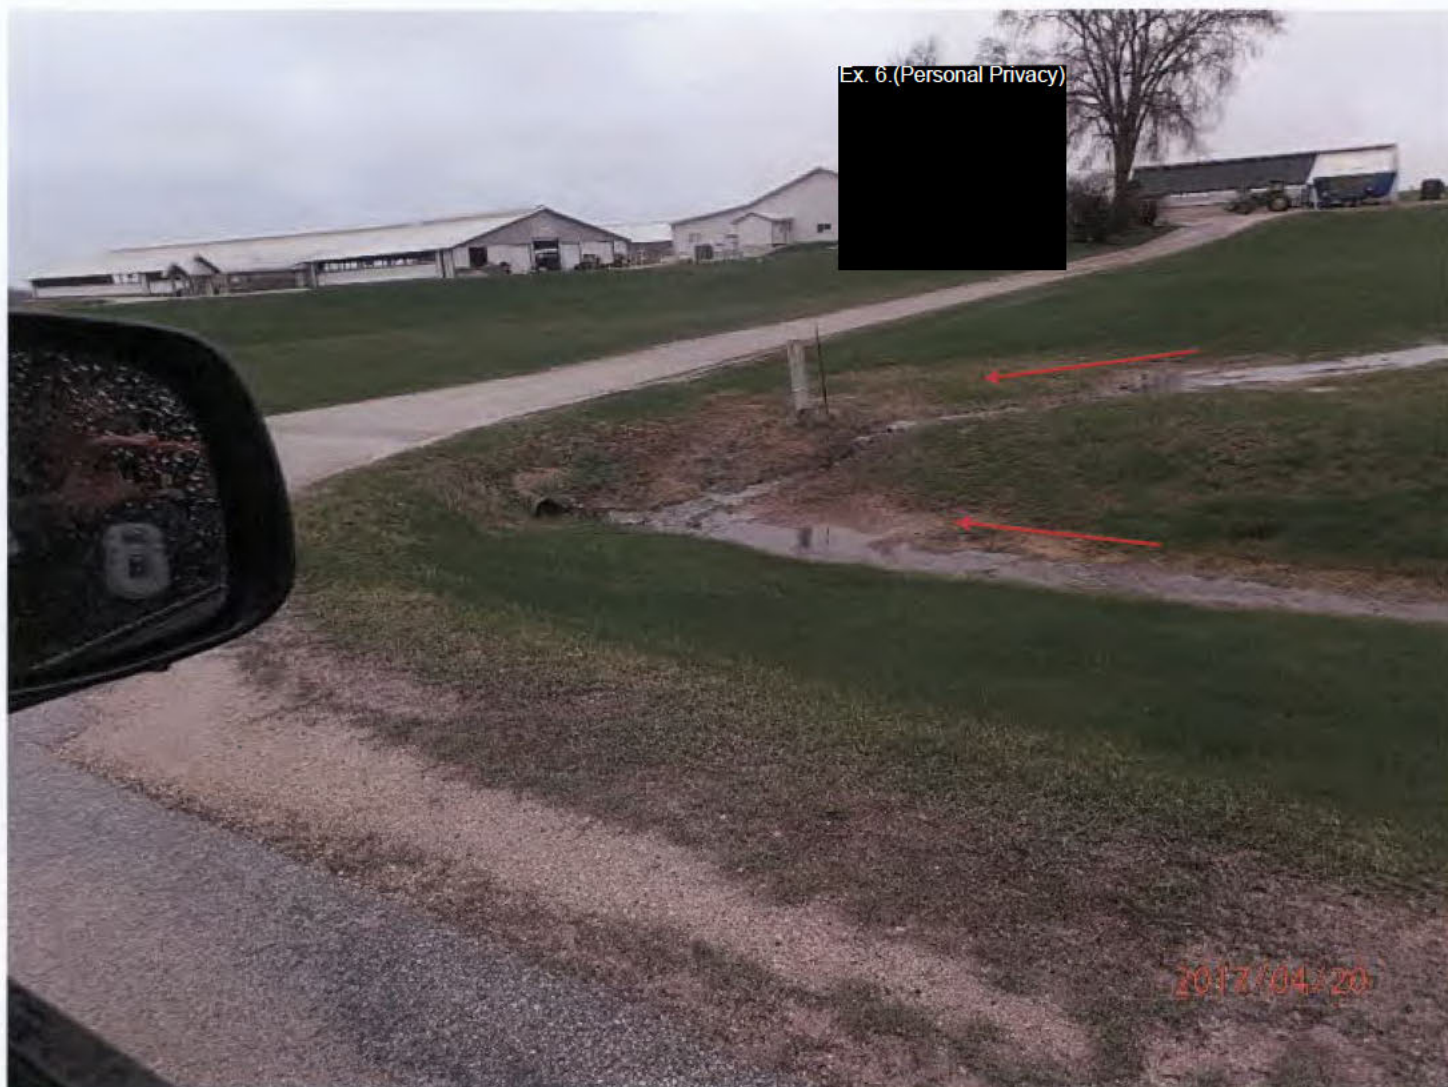
Photo Number: P4200017

Description: Arrows in the photo depict the direction of flow of the two process wastewater pathways as they converge and flow through the culvert that runs under the 2nd driveway west of Lilac Lane.

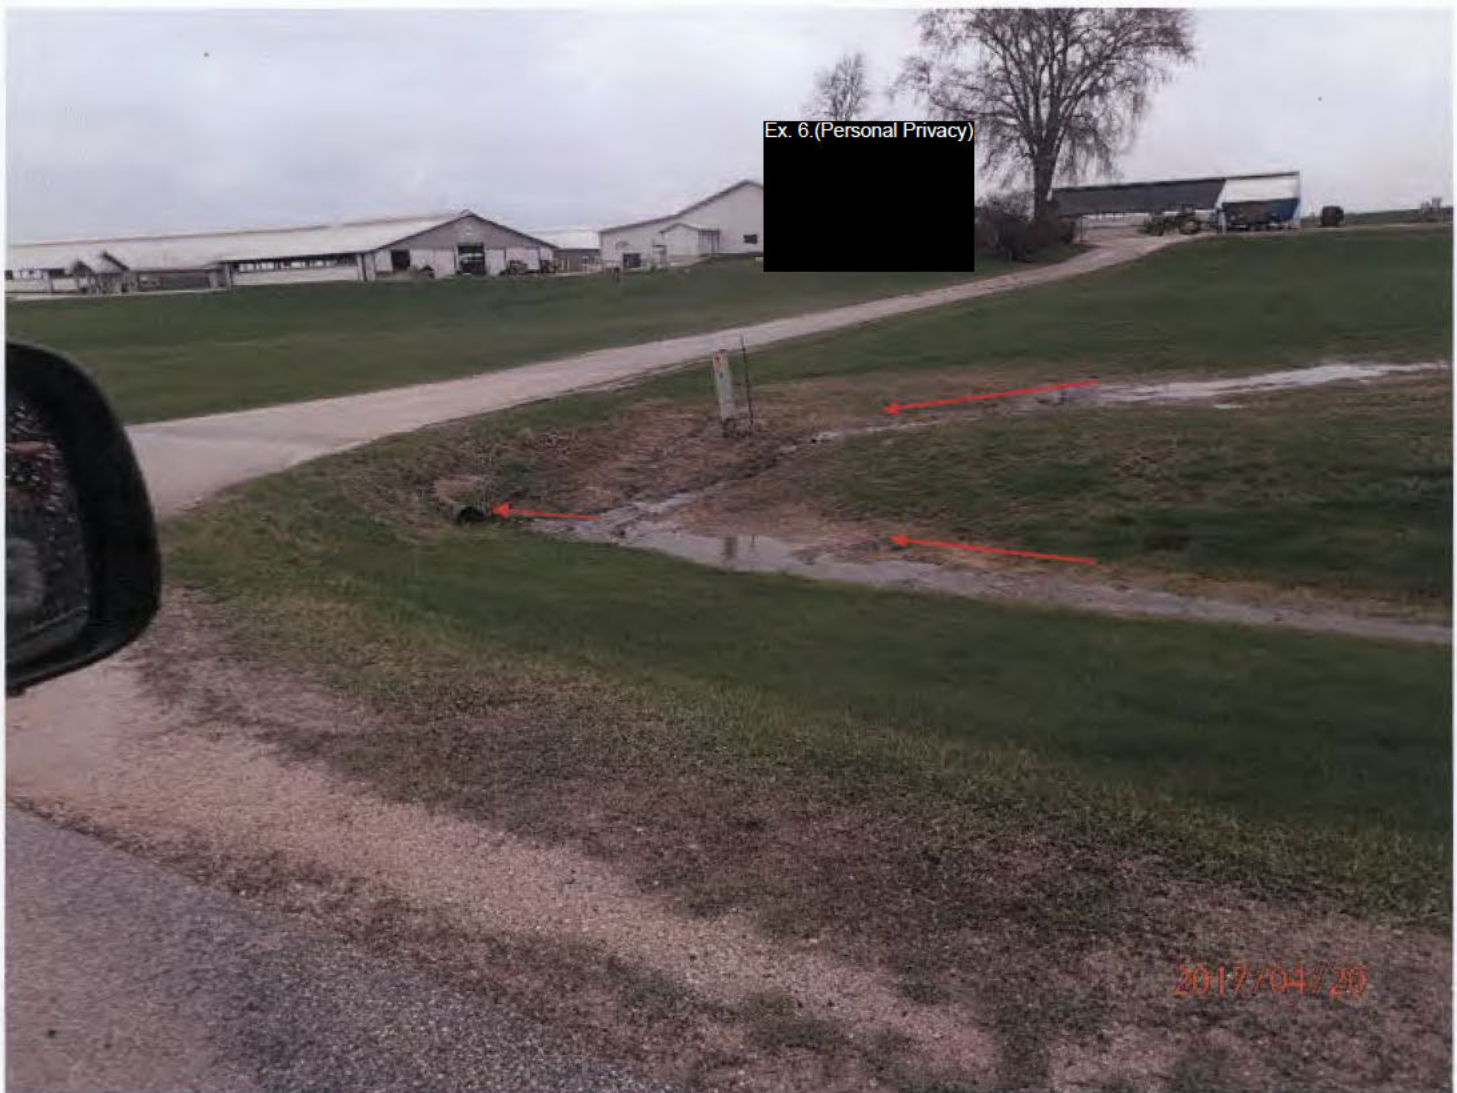
Photo Number: P4200018

Description: Arrows in the photo depict the direction of the process wastewater pathways as they converge and flow through the culvert that runs under the 2nd driveway west of Lilac Lane.

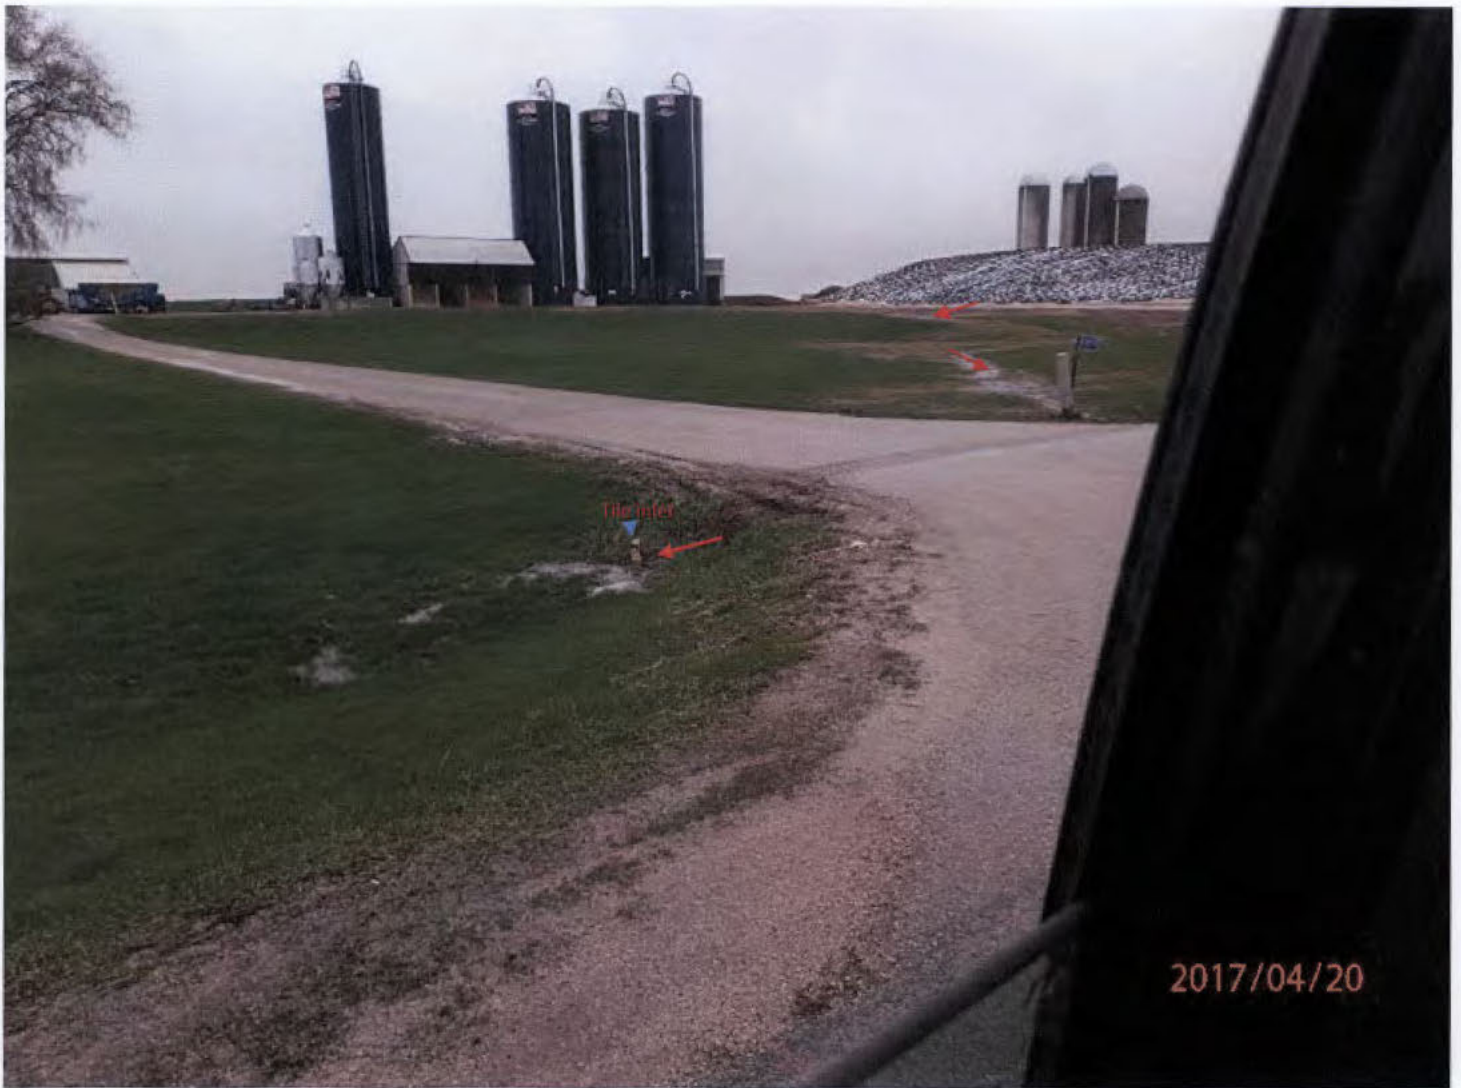
Photo Number: P4200019

Description: EPA observed the process wastewater flowing off of the west side of the silage pad and flowing to the southwest through the grass depicted by the arrows. The flow of the process wastewater continues through the culvert under the 2nd driveway west of Lilac Lane discharging into the tile inlet.

On April 20, 2017, EPA conducted an unplanned reconnaissance inspection along the public road right-of-ways near Legend Farms Dairy, LLC (Facility). EPA was there to observe whether the alleged discharges observed on May 26, 2016 had been remedied as claimed by the photographs Ex. 6.(Personal Privacy) e-mailed to Kevin Chow, EPA Office of Regional Counsel on August 25, 2016. Upon their arrival at approximately 8:30 AM, EPA inspectors observed two discharges off of the west and east sides of the silage pad into the roadside ditches as documented in photo numbers P4200017-P4200026. One flow path originated on the west side of the silage pad and flowed southwest to the roadside ditch along the north side of County Road F. The second flow path originated on the east side of the silage pad and discharged off of the east side of the silage pad and into the roadside ditch along the west side of Lilac Lane and continued to flow south into County Road F roadside ditch. EPA observed that feed and surface runoff (process wastewater) from the silage pad was discharging in the flow paths. EPA also observed that Lilac Lane was the high point in the surrounding terrain and all liquid in the roadside ditch appeared to originate from the Facility. The process wastewater flowed through two culverts along County Road F as identified in this report as 1st driveway west of Lilac Lane and 2nd driveway west of Lilac Lane. The process wastewater flowed through the culvert under the 2nd driveway west of Lilac Lane and into a tile inlet as documented in photo P4200019.

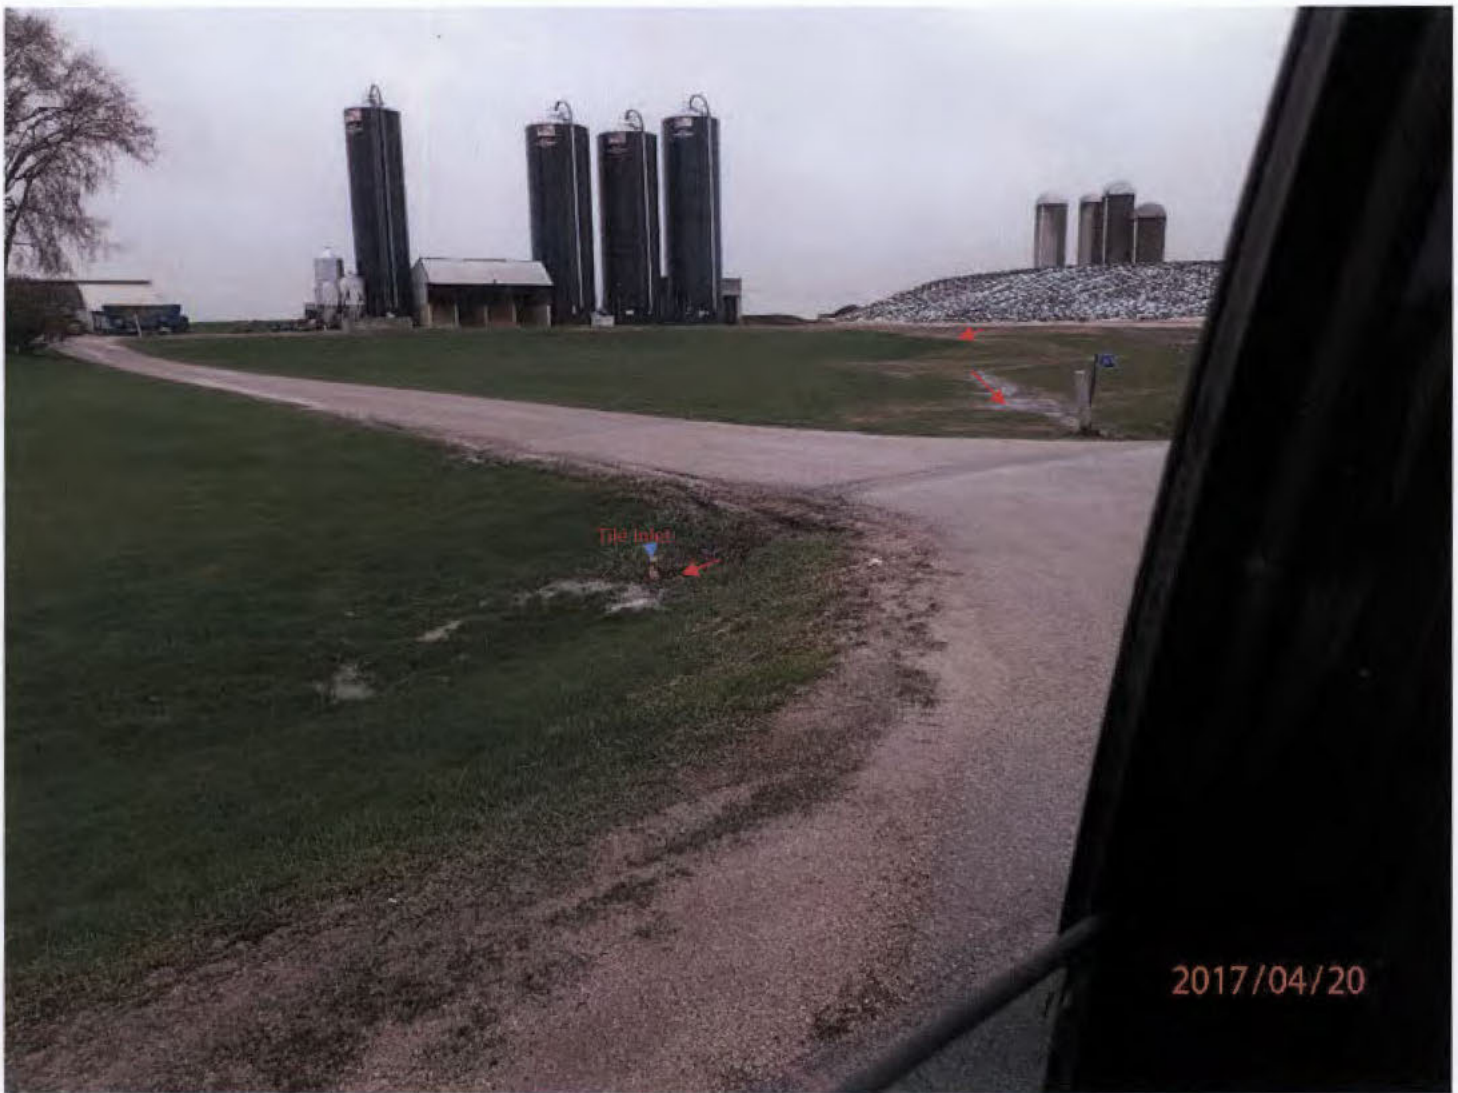
Photo Number: P4200020

Description: EPA observed the process wastewater that flowed off of the west side of silage pad and flowed southwest through the grassy area depicted by the arrows in the photo. The process wastewater flows through the culvert under the 2nd driveway west of Lilac Lane to the west and discharges into the tile inlet.

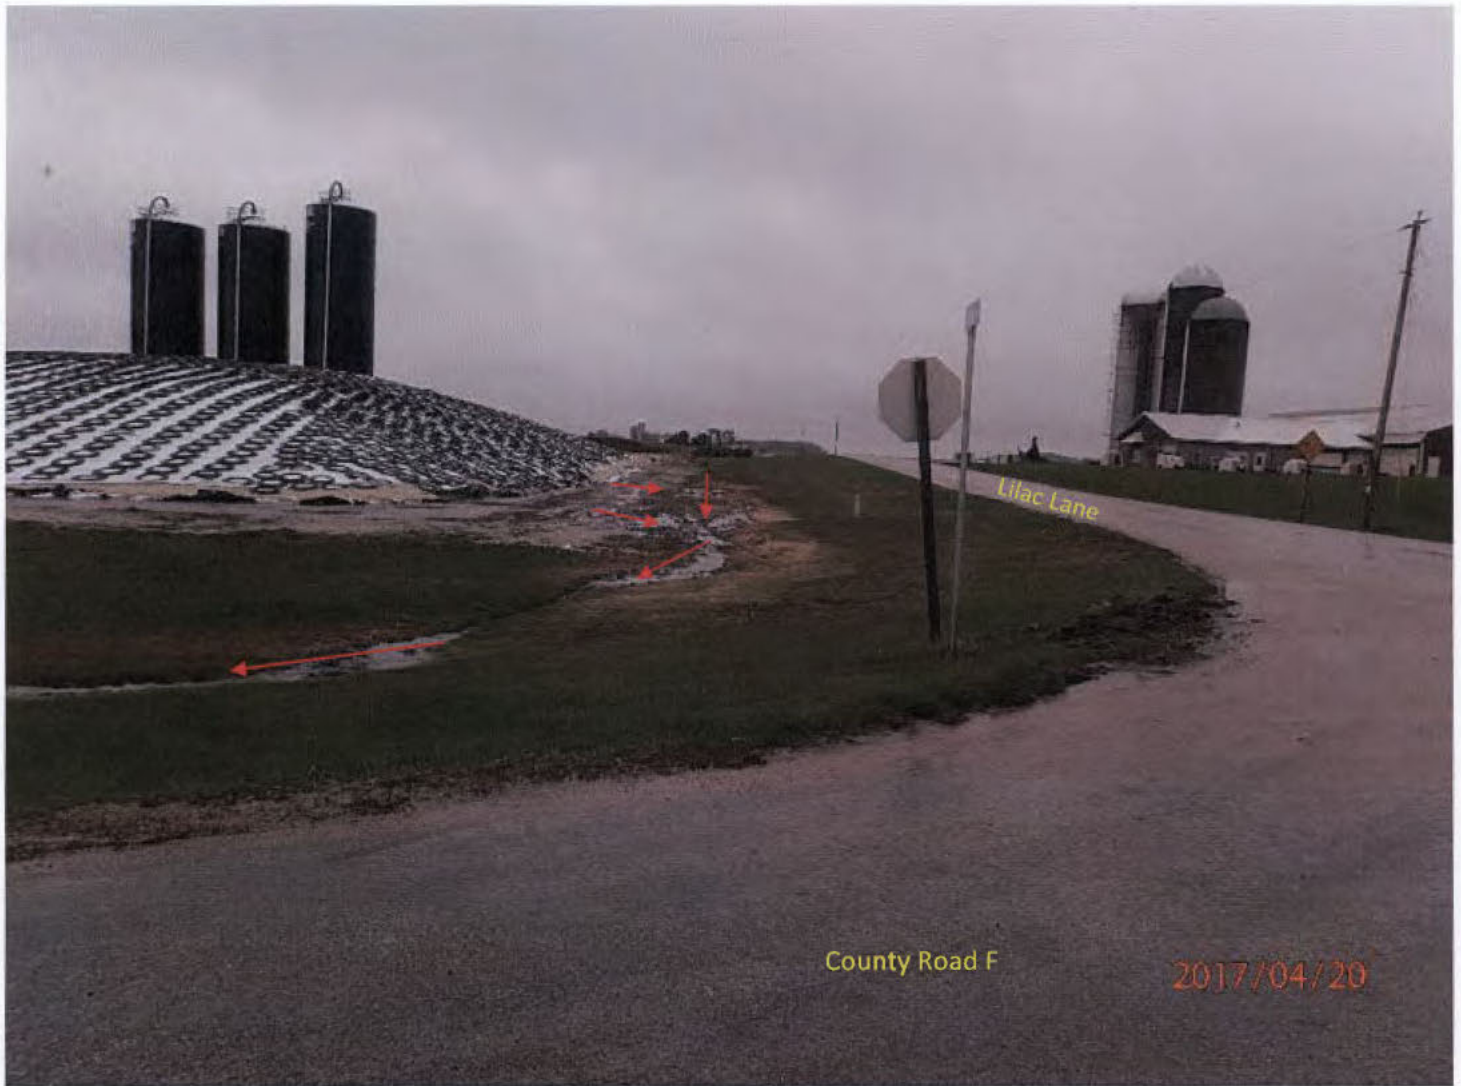
Photo Number: P4200021

Description: EPA observed the process wastewater that discharged off of the silage pad to the east into the roadside ditch on the west side of Lilac Lane and flowed south toward County Road F as depicted by the arrows in the photo. The flow continues to the south around the bend flowing west in the roadside ditch along the north side of County Road F.

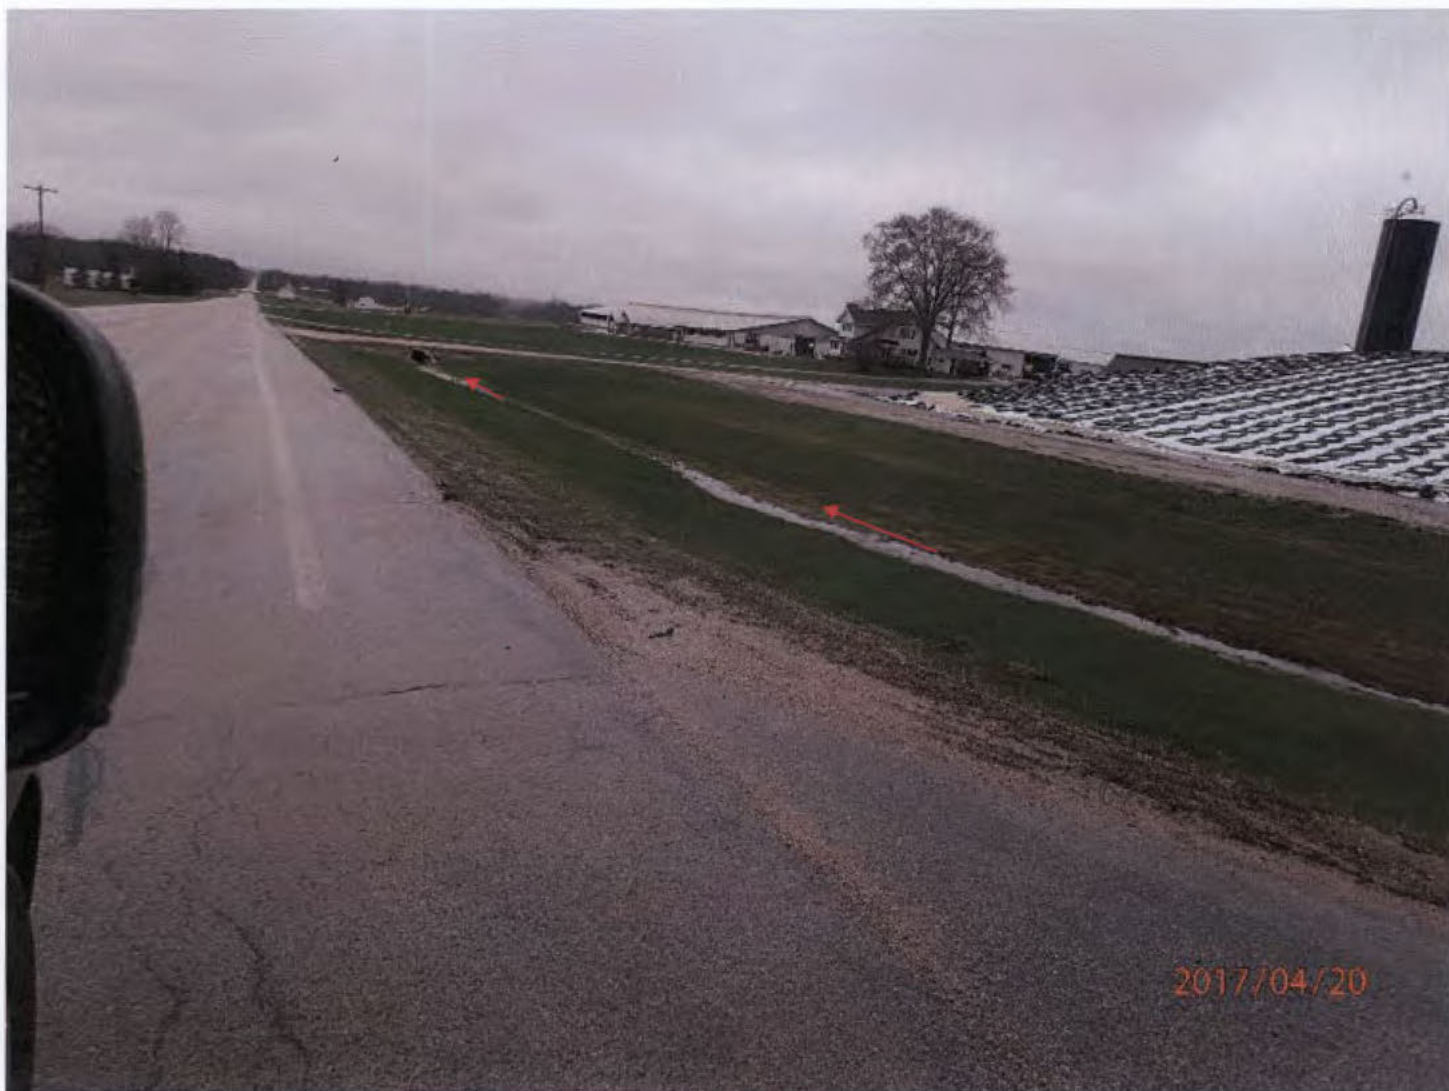
Photo Number: P4200022

Description: EPA observed process wastewater flowing west in the roadside ditch on the north side of County Road F. The arrows depict the direction of flow of the process wastewater in the roadside ditch. The process wastewater continues to flow west through the culvert under the 1st driveway west of Lilac Lane.

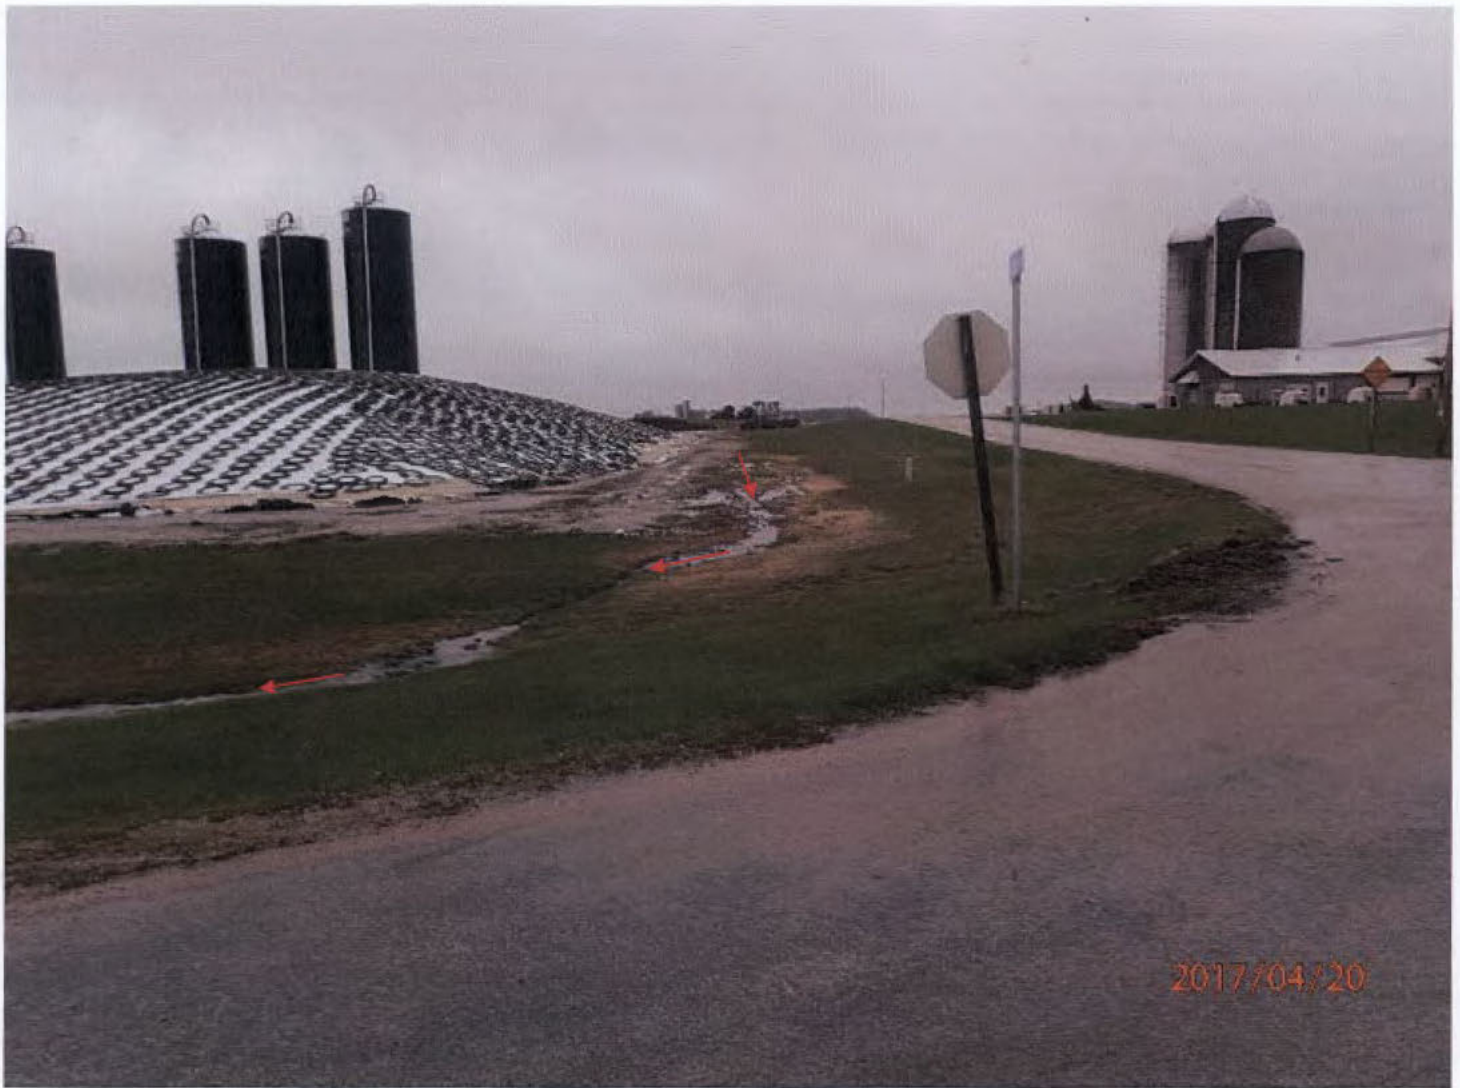
Photo Number: P4200023

Description: EPA observed process wastewater discharging off of the east side of the silage pad into the roadside ditch west of Lilac Lane. The process wastewater flows south into the roadside ditch north of County Road F as depicted by the arrows in the photo.

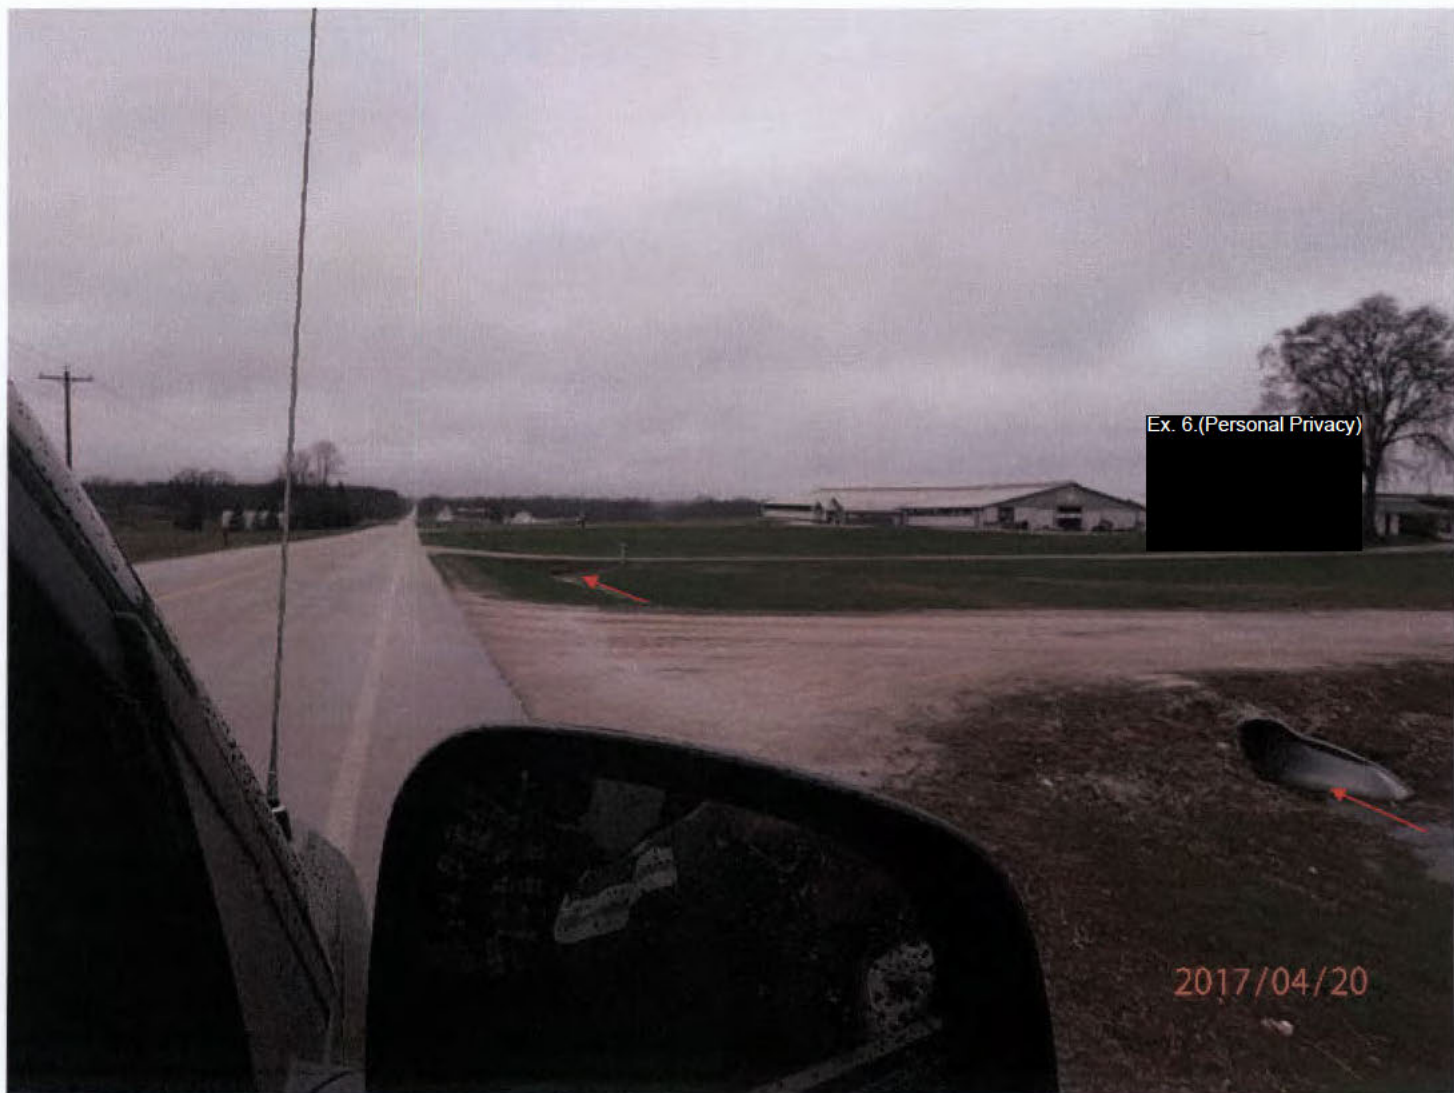
Photo Number: P4200024

Description: EPA observed process wastewater flowing through the culvert under the 1st driveway west of Lilac Lane and continuing to flow west toward the 2nd culvert that runs under the 2nd driveway west of Lilac Lane.

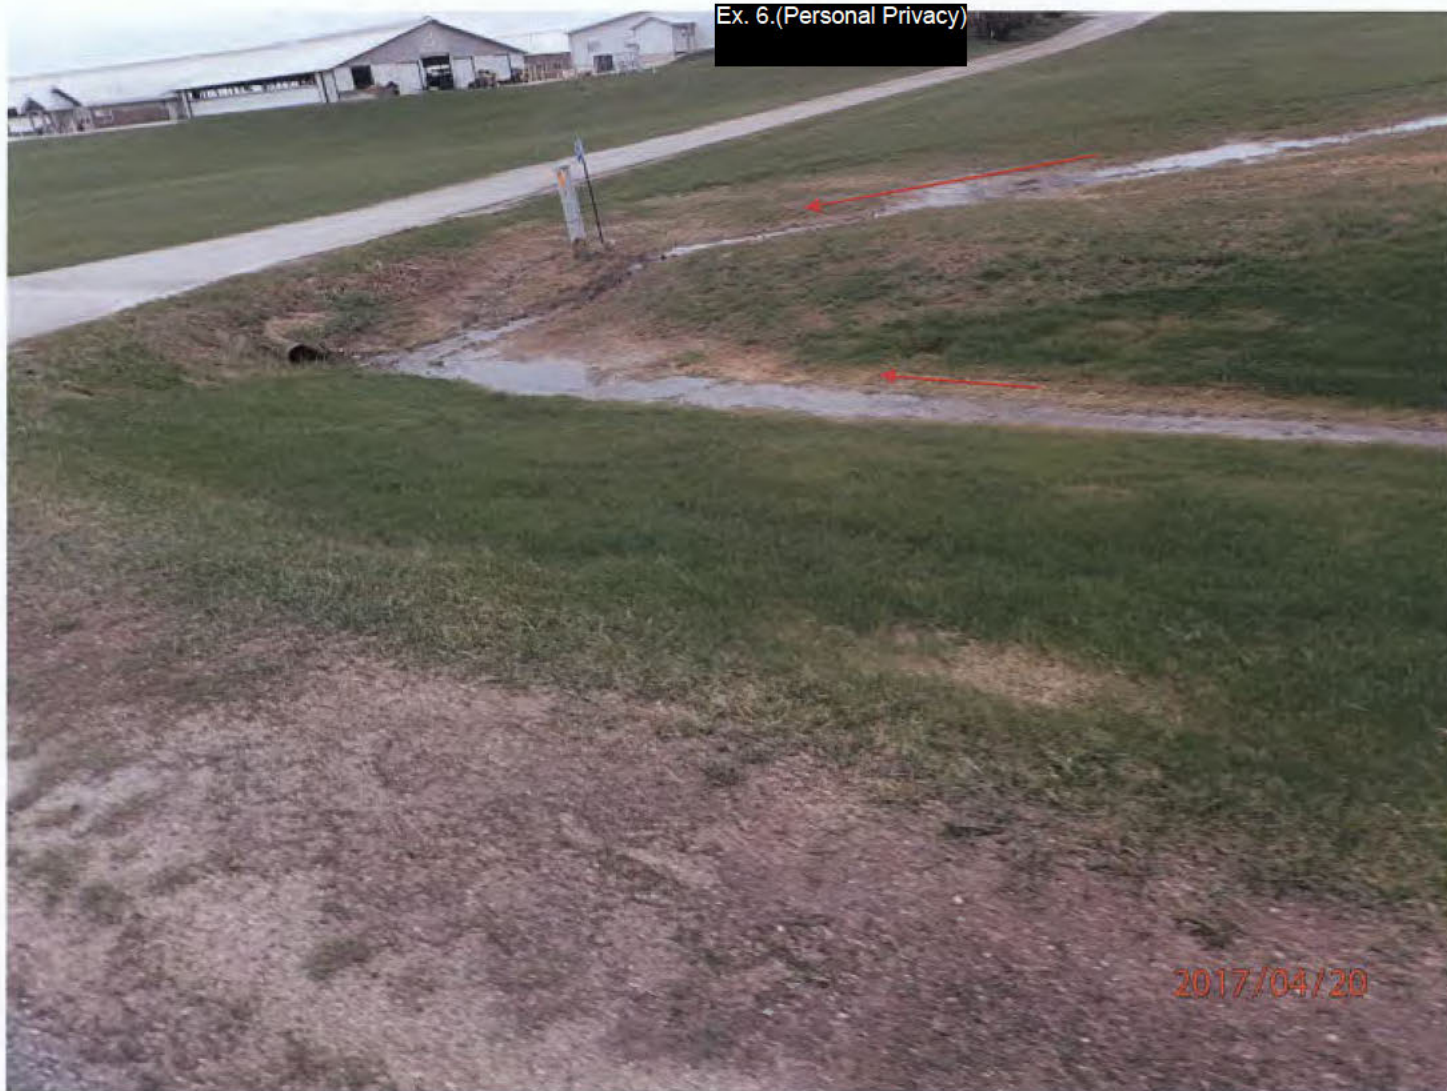
Photo Number: P4200025

Description: EPA observed the two flow pathway discharging off of the silage pad converge and flow through the culvert under the 2nd driveway west of Lilac Lane on the north side of County Road F. Arrows depict the convergence of the two flow pathways of process wastewater.

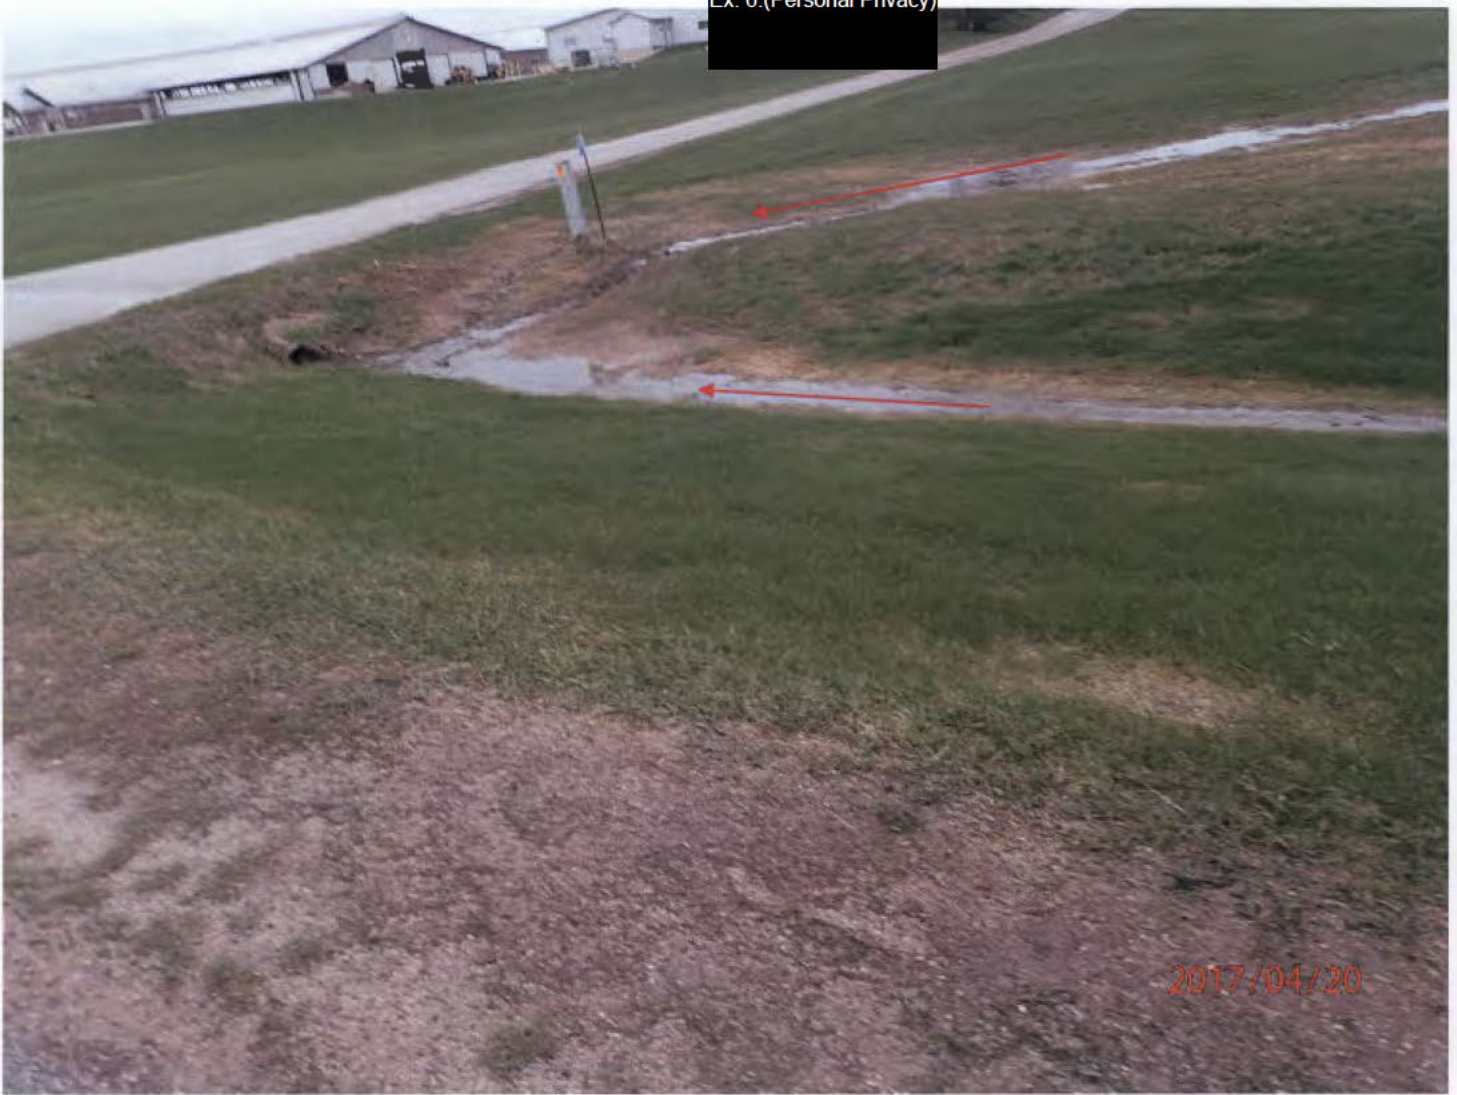
Photo Number: P4200026

Description: EPA observed process wastewater that discharged off of the silage pad converge and flow through the culvert under the 2nd driveway west of Lilac Lane. Arrows depict the convergence of the process wastewater.

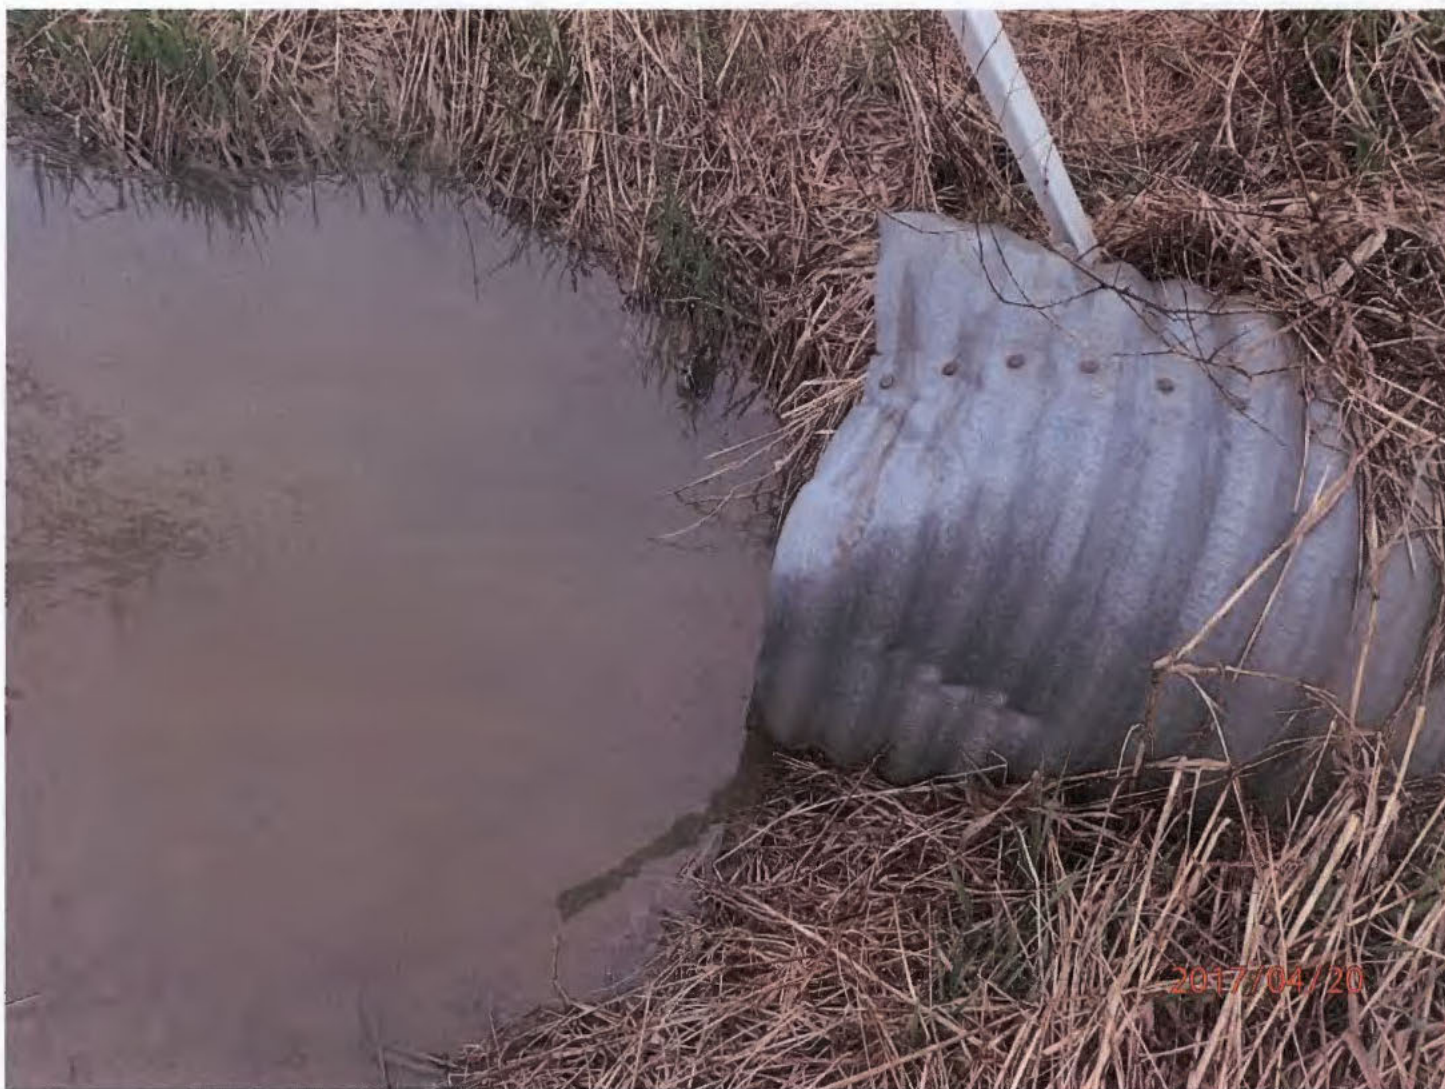
Photo Number: P4200027

Description: Culvert outlet on the south side of County Road F.

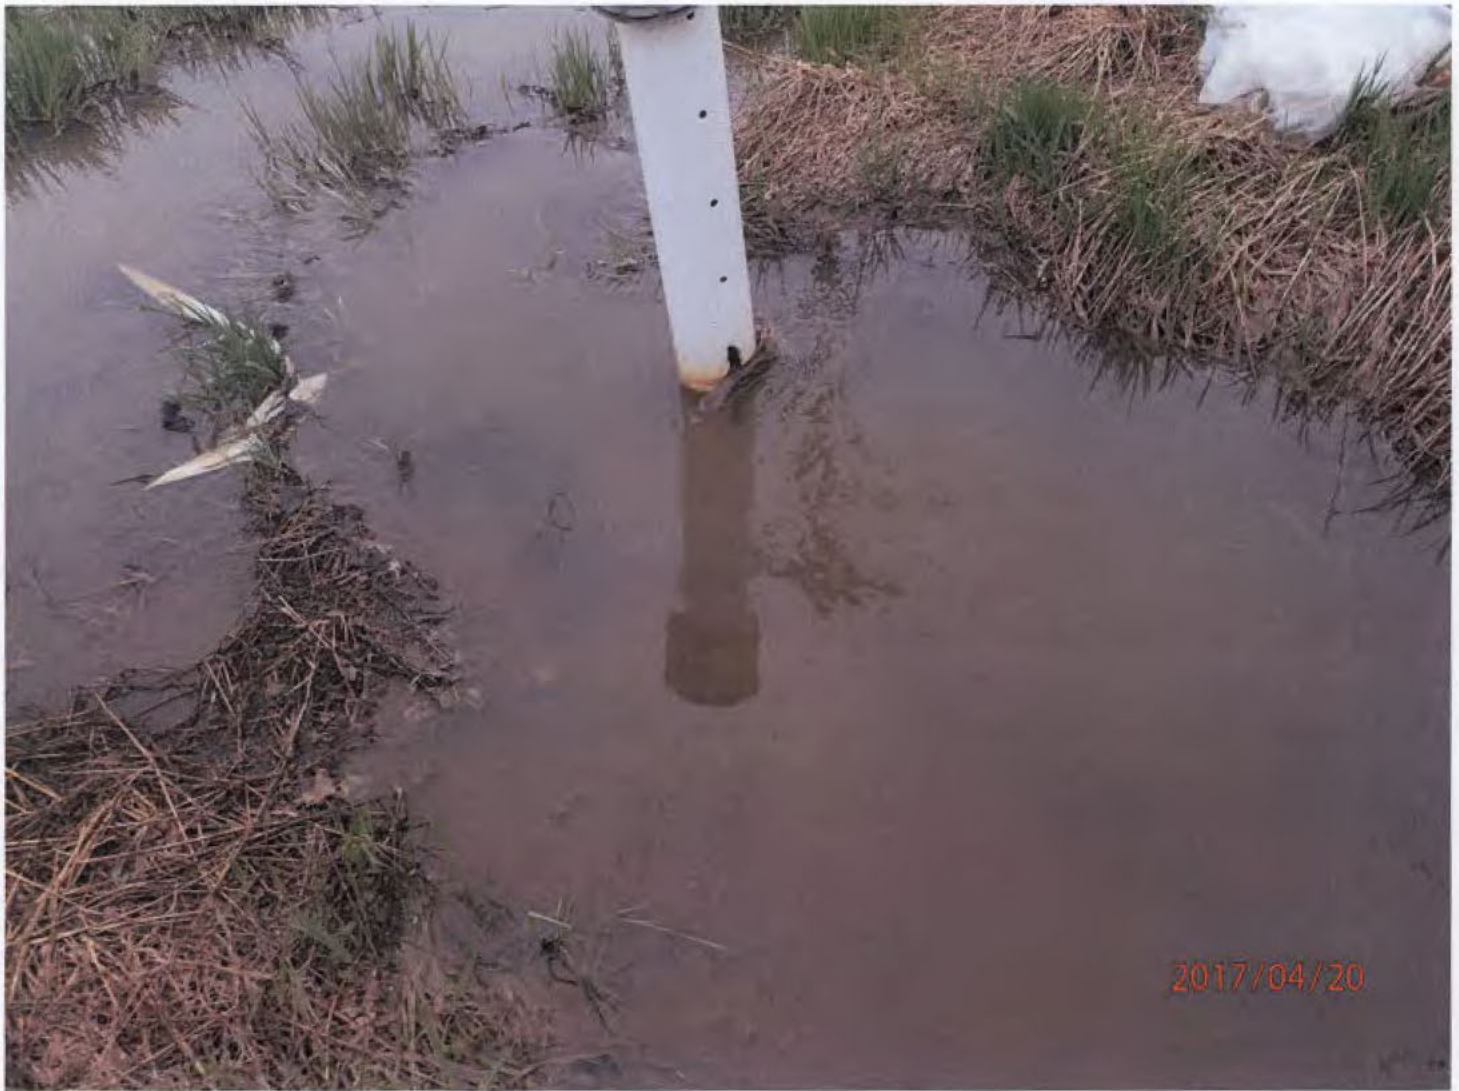
Photo Number: P4200028

Description: Tile riser located on south side of County Road F.

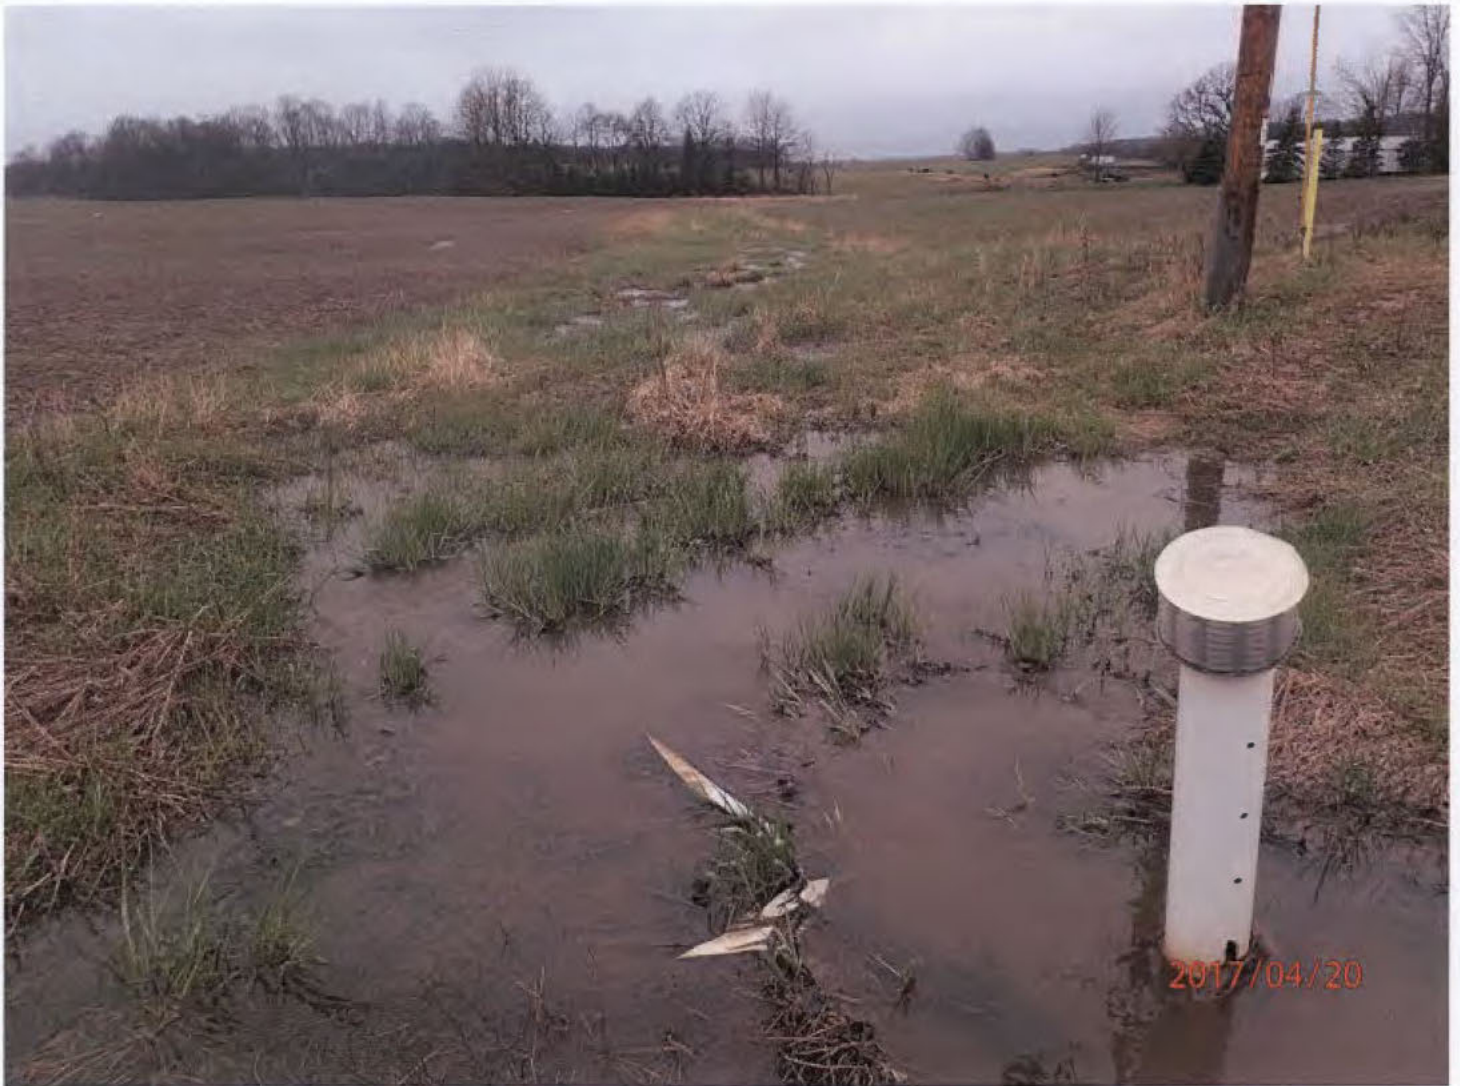
Photo Number: P4200029

Description: Tile riser located on south side of County Road F.
